RENOVATION SURVEY FOR ASBESTOS CONTAINING MATERIALS & LEAD BASED PAINT

**Lincoln Correctional Facility
31-33 West 110th Street
New York, New York 10026-4398
Adelaide Project# OGS:09138.00-IN
OGS Project# EA927**

**LIMITED ASBESTOS, LEAD, AND PCB SURVEY
LINCOLN CORRECTIONAL FACILITY
31-33 WEST 110TH STREET
NEW YORK, NY 10026**

REPORT OF
ASBESTOS AND LEAD-BASED PAINT SURVEY SERVICES
FOR
LINCOLN CORRECTIONAL FACILITY
-INVESTIGATE & REPAIR ROOF LEAKS-
31-33 WEST 110TH STREET
NEW YORK, NEW YORK 10026

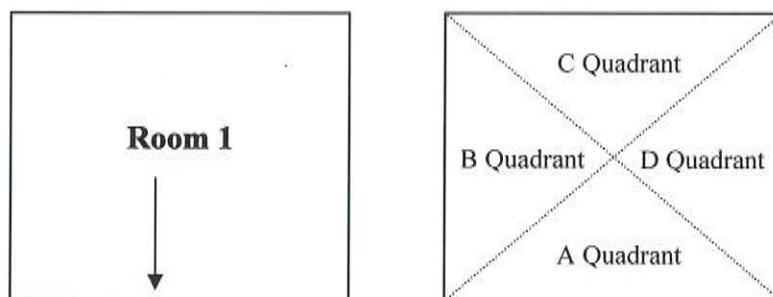
Diagram 1

Lead based paint and lead containing paint was confirmed in some of the areas in the path of renovation. Location identifiers (reading numbers) were assigned to each room component. Each location sampled has a unique number. The associated sample results will be listed by room number, room location, room name, location in the space and description of material sampled. By convention a sample location is assigned a letter designator for each of the four walls. This divides the space into four equal quadrants, each quadrant consisting of a wall, portion of the floor and a portion of the ceiling. Please see Diagram 1. These letter designators are A, B, C and D. On the diagrams provided, the letter designators are marked for each of the quadrants. In this fashion the sampled space, location in the space and the description of the material sampled can be identified on the attached drawings and associated results table.

When any construction/renovation is to take place within areas that lead paint or lead containing paint was confirmed, the following response actions must be implemented as part of the construction/renovation project.

The renovation work at Lincoln Correctional Facility may require the disturbance of lead-containing paint. Lead-containing paint was detected on surfaces that could potentially be disturbed by renovation/construction work. Any contractor disturbing a lead-containing material is directed to comply with all applicable laws and regulations governing the disturbance of lead containing materials including but not limited to *Occupational Safety and Health Administration (OSHA)* standards including *Construction Lead Standard 29 CFR 1926.62*. Air monitoring for employee exposures should be performed in accordance with the National Institute for Occupational Safety and Health (NIOSH) 7300 Method or equivalent. As an alternative to air monitoring, the contractor may provide objective data per 29 CFR 1926.62 Section (d)(3)(iv). The contractor shall employ work practices and controls to prevent the occurrence of lead contamination at the Site.
